Manhole Inspection Summary

Manhole # S29KK_003MH

Printed On: 12/17/2008

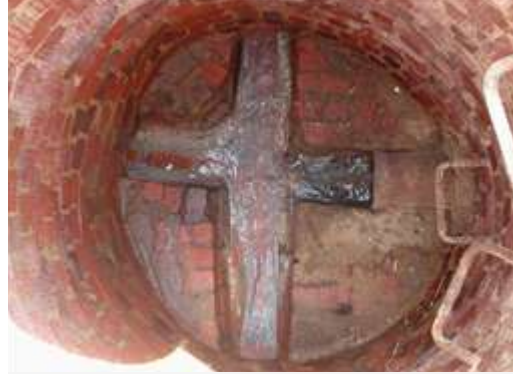
Top View

Corroded steps. Evidence of surcharge - Bench debris.

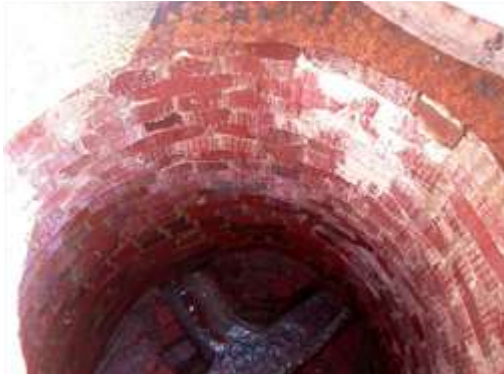
Defect

Frame leaks. Adjustment deterioration and infiltration. Barrel infiltration - other side.

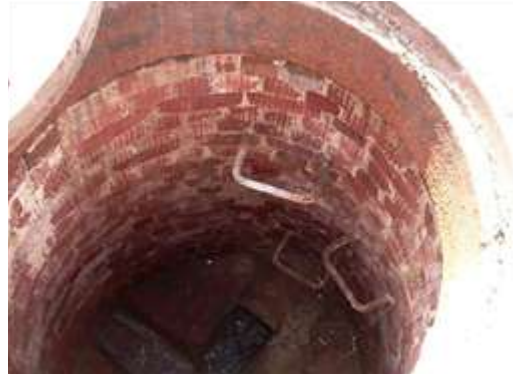
Defect

Frame leaks. Adjustment deterioration and infiltration. Barrel infiltration.

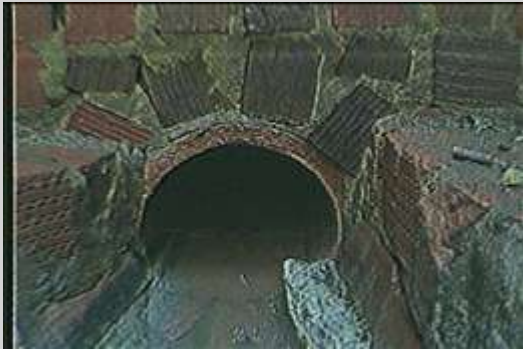
8 in. Circular Gravity Sewer Pipe Out @ 12 O'Clock

Deposits: ☐ None ☐ Mud ☐ Sludge ☐ Debris ☒ Grease

Silt Depth: **0** (in.) Deposits Extent: **Light**

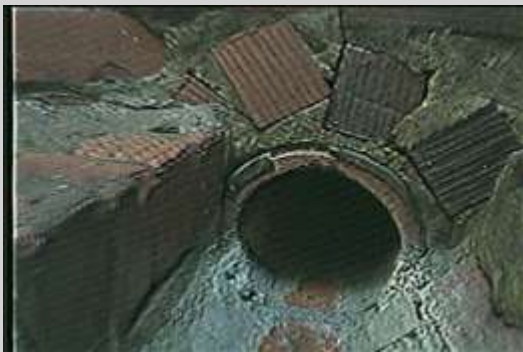
Pipe In @ 9 O'Clock

Channel deterioration.

Deposits: ☐ None ☐ Mud ☐ Sludge ☐ Debris ☒ Grease

Infiltration: **Evidence** Pipe Seal Cond: **Broken**
